# Exterior Envelope Evaluation for the Indian Health Service Albuquerque Service Unit Campus, Albuquerque, NM

**Schedule:** 2018

**Client:** Indian Health Service, Albuquerque Service Unit

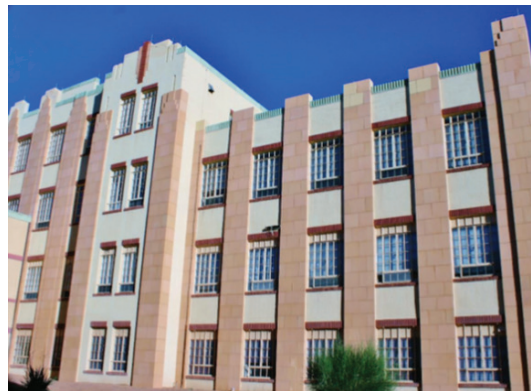
**Main Building 21 FL- 1st south WINDOW 1A**

Component	Good	Fair	Poor	Comments
Frame	X			Steel Sash Original Historic Fabric
Exterior Brick Sill		X		Clean and repoint bricks
Ext. Brick coping	X			Clean and repoint bricks
Upper Sash				Double Casement 2 over 4
Lower and side lite Sash				2 Fixed Multi Lite side 5 lites each 1 Lower Hopper 1 over 4
Steel lintel		X		Exposed steel lintel needs caulk and paint
Parting Stops				n.a.
Interior Stops				n.a.
Glass		X		Top row of glass painted out
Glazing Compound		X		Needs some replacement and paint
Other			X	Edge sealant needs touch up
Sash Lifts				n.a.
Sash Locks		X		
Screen				No screen
Paint		X		Needs re-paint*

\*Possible lead paint issues
